ALERTS

LEARNING FROM OTHERS

Hydraulic Ram Top Link

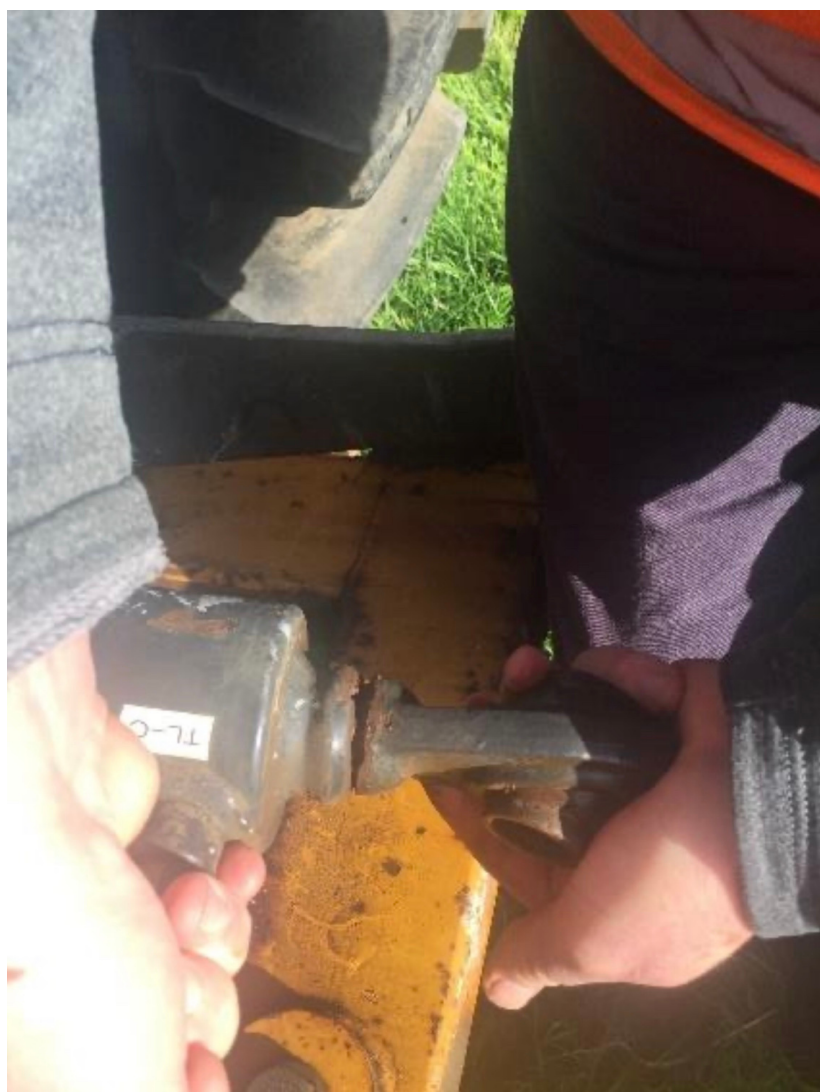
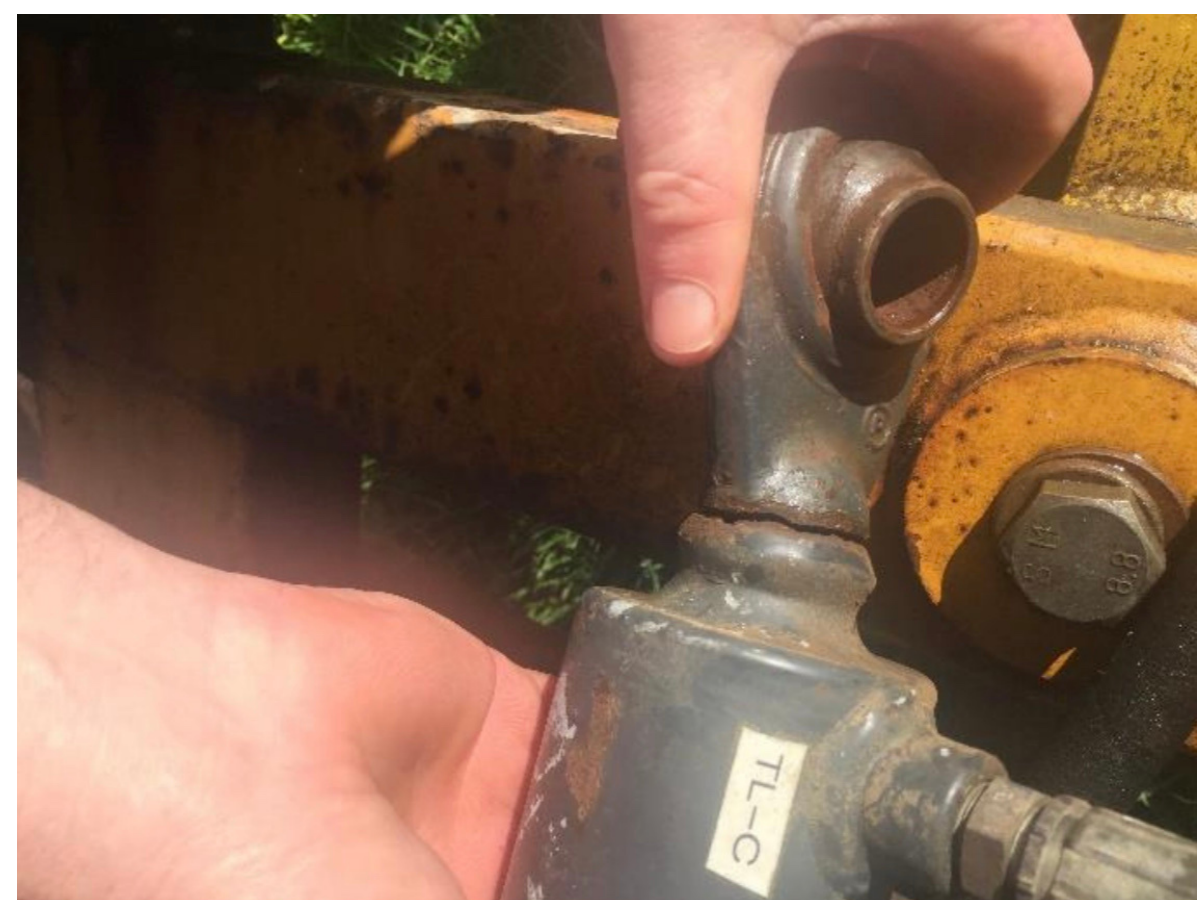
A hydraulic top link has snapped with the attachment dropping. In this situation a post rammer was attached with potential for a worker traveling behind the tractor on a 2-wheel motorbike being hit. The weld had some visible rust.

- Please check all welds on hydraulic components for any visible rust, cracking, or paint discolouration.
- If an issue is identified, please report to your manager for follow-up investigation.
