ALERTS

LEARNING FROM OTHERS

Mower detached from Tractor

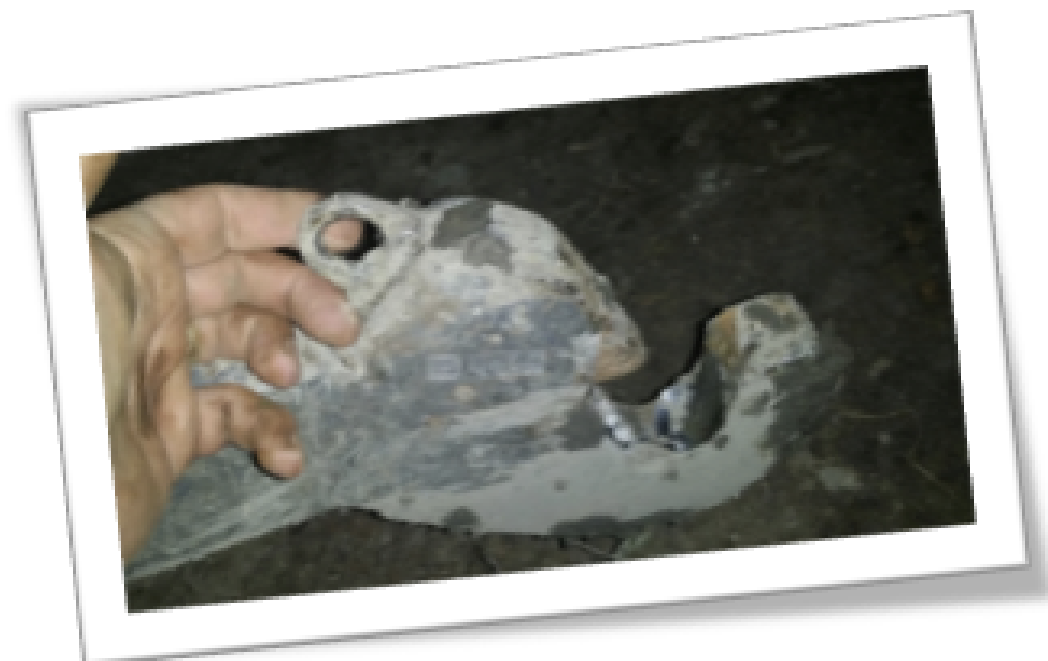
On 4th October 2017 a Richburn tractor had its mower detach from the 3 point linkage arm while transiting around the yard.

The investigation found the fault lay with the wear of the 3 point linkage quick hitch lock coupling and wear to the ball.

- Always complete a thorough pre start check ensuring the couplings are correctly secured and there is no play.
- The driver is the person who is responsible for checking the equipment.
- We need to check all tractor 3 point linkage coupling points and balls to ascertain if there is wear - if there is play we need to replace the linkage and balls.
- Check that the 3 point linkage quick hitch is in good working order and is down and seated.
