ALERTS

Poorly maintained tripod tanks

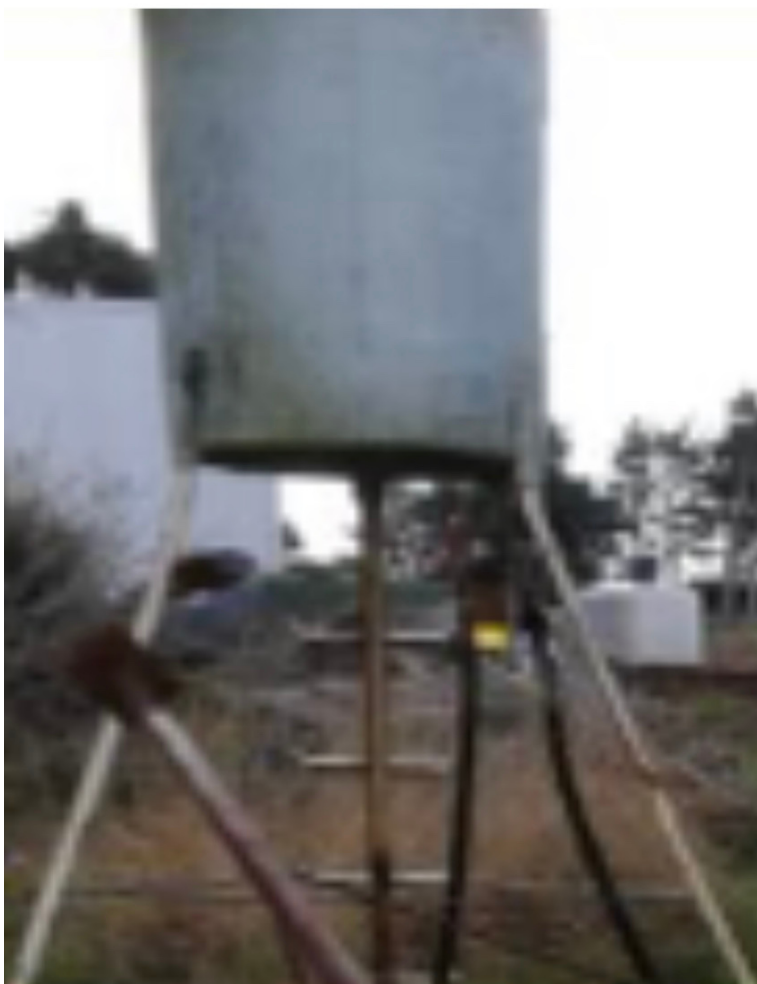
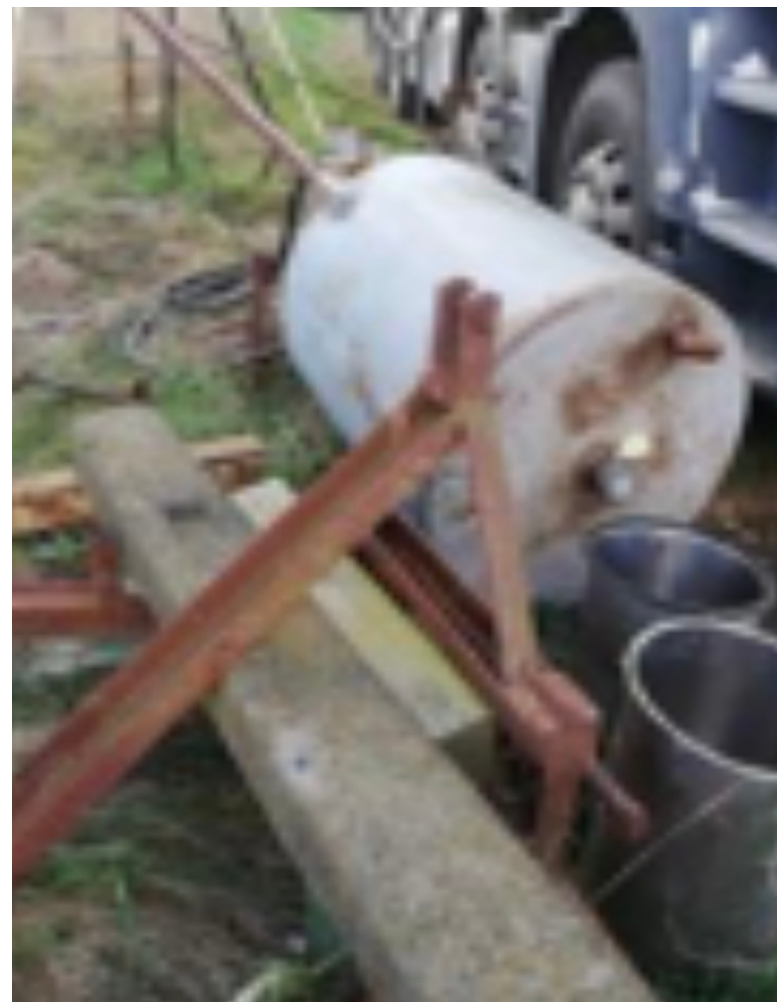
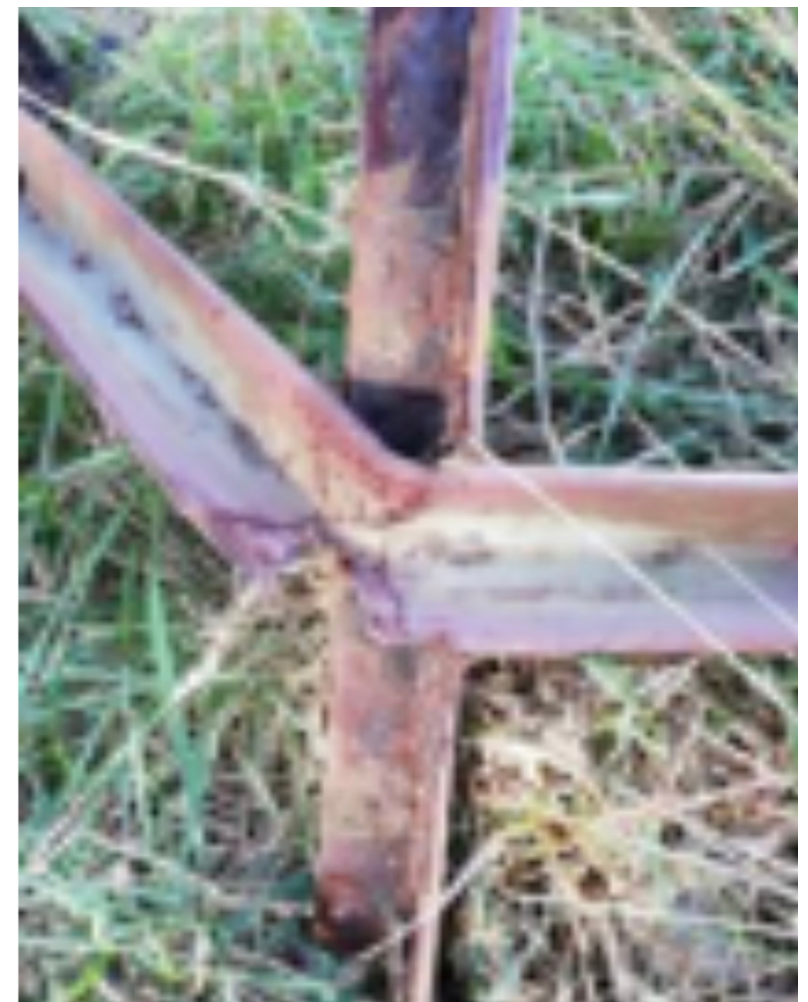
A fuel tanker driver was *seriously injured* in a recent incident on a farm in which a tripod overhead tank collapsed while he was filling it. The root cause of the collapse was significant corrosion (rust) on one of the tank legs. Farm implements close to the tank also contributed to the driver's injuries.

- Check all your fuel tanks and support structures for signs of corrosion (rust) and metal fatigue and if there is rust or fatigue, consider tank replacement options.
- Make sure all tanks are properly secured to a flat foundation
- Ensure the work area around each tank is safe, with a clear path free of obstacles.
