ALERTS

LEARNING FROM OTHERS

Calfeteria Rollover

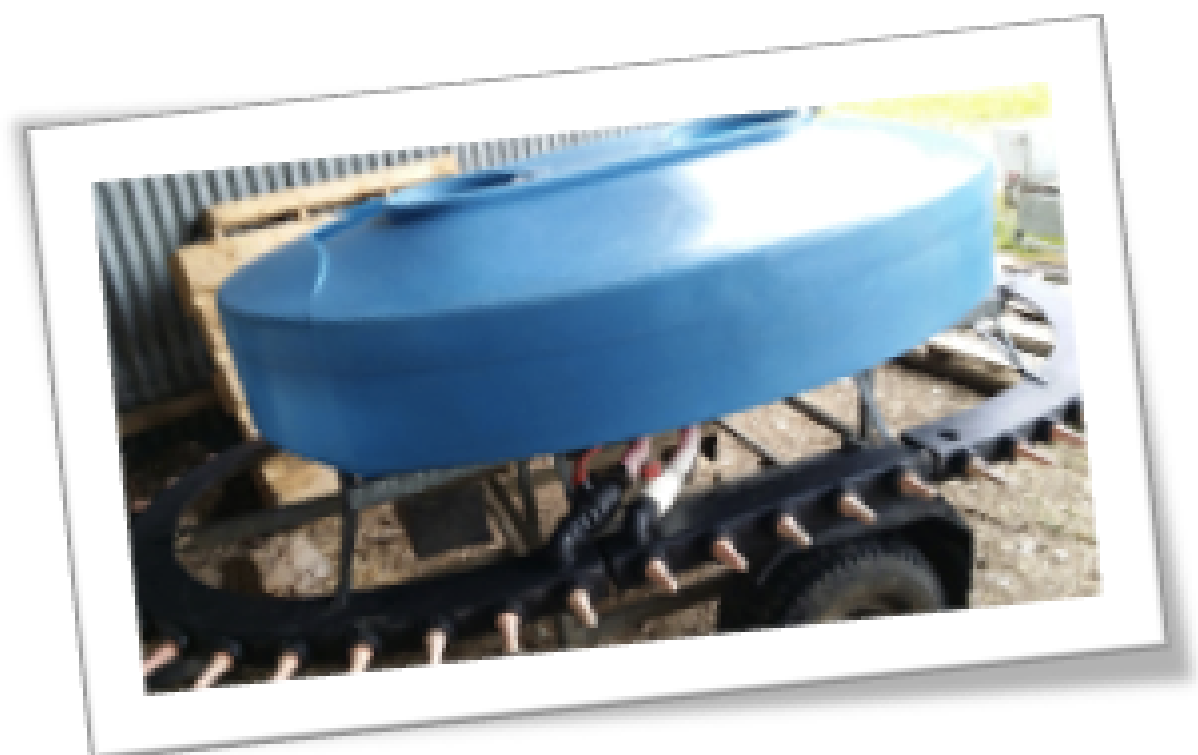
On 15th October 2017 a Betapahu calfeteria (mobile calf feeder) rolled over while trying to get away from the calves and back to the gate. Fortunately no one was injured as the calfeteria turned it dislodged from the tow ball. The consequences of the incident could have been much worse if there was more weight in the calfeteria and more speed. It did however cause significant damage to the feeder and is in need of repair.

- Review your own procedures to ensure all staff are aware on any risk and correct operating procedure.
- This operator in this case has had Quad training and was active riding.
- In this case important to note the milk was slushing around and as it turned at speed it raised the centre of gravity higher causing it to tip over.
- Train the calves to not chase the feeder once fed - use an old milk bottle with stones to make some noise when have had their milk allocation. They will learn they cannot chase the feeder after feeding.
